# SERVICE BULLETIN

**Subject: GS-X Nexgen Rear Display Upgrade Package****Date: 8/18/10****Bulletin No. SB10-10**

## **Nexgen Rear Display 47-861048-000**

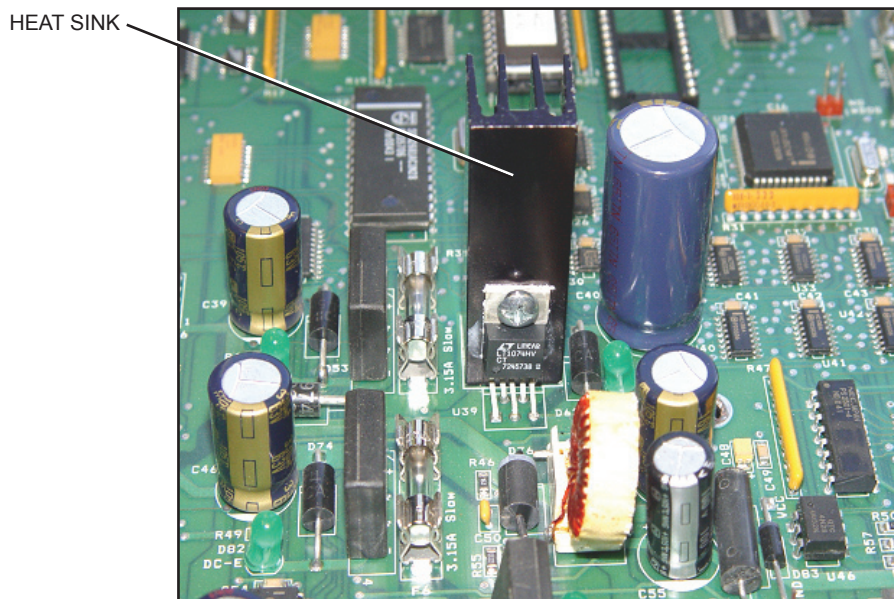
*Figure 1 - Modified CPU with Heat Sink*

Please note that in bowling centers where GS-X pinsetters were installed in the years 2000 to 2003 (Series Number 465 – 510) with Nexgen CPU PCBs, the communication circuit was not enabled. This will prevent correct communication through the I/O PCB to the Rear Display. If the Rear Display unit is installed on pinsetters with this version of the CPU PCB, a “NO COM” error will be displayed on the Rear Display. Before attempting to install this package, you will need to identify if the upgrade is needed.

1. Disconnect power to the pinsetter by turning off the main power switch and unplugging the power cord to the Nexgen Box.
2. Locate the CPU PCB board and check if Regulator U39 has a black heat sink attached and is soldered on the board. Refer to *Figure 1*.

- a. If the CPU PCB has the heat sink soldered onto the board, the board will operate as needed and the Rear Display package can be installed.
  - b. If the CPU board does not have this heat sink, it will need to be modified as it will not communicate with the Rear Display unit.
3. If a heat sink is not present, the CPU PCBs will need to be exchanged with upgraded PCBs. To receive exchange PCBs, contact the Brunswick Electronic Repair Center or an authorized Exchange Depot. Please note that an exchange fee will be charged for each board. You can contact the Electronic Repair Center by calling 1-800-937-2695 or 231-725-4966, or sending an e-mail to [erc@brunbowl.com](mailto:erc@brunbowl.com) to receive a CPU upgrade replacement and current pricing information.

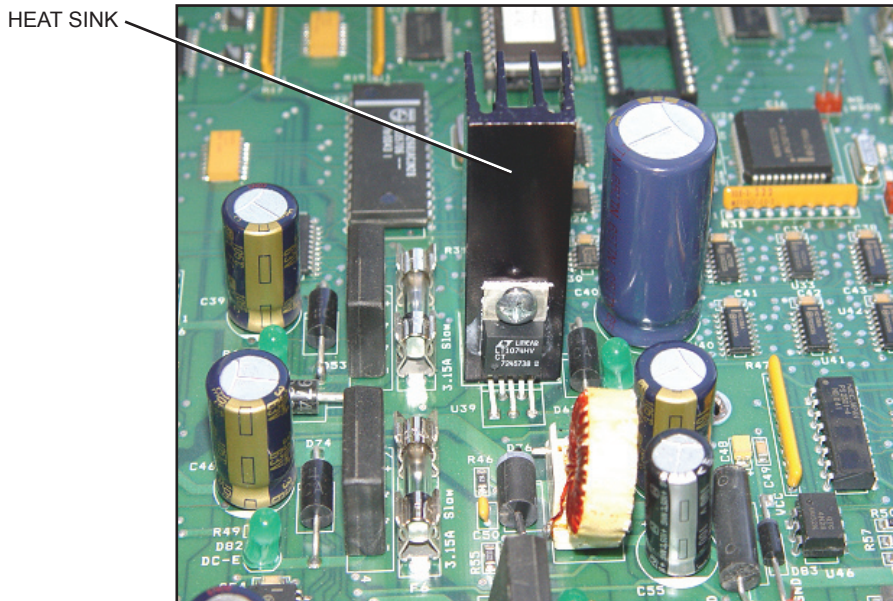
*Figure 1 - Modified CPU with Heat Sink*

Please note that in bowling centers where GS-X pinsetters were installed in the years 2000 to 2003 (Series Number 465 – 510) with Nexgen CPU PCBs, the communication circuit was not enabled. This will prevent correct communication through the I/O PCB to the Rear Display. If the Rear Display unit is installed on pinsetters with this version of the CPU PCB, a “NO COM” error will be displayed on the Rear Display. Before attempting to install this package, you will need to identify if the upgrade is needed.

2. Locate the CPU PCB board and check if Regulator U39 has a black heat sink attached and is soldered on the board. Refer to *Figure 1*.

- a. If the CPU PCB has the heat sink soldered onto the board, the board will operate as needed and the Rear Display package can be installed.
  - b. If the CPU board does not have this heat sink, it will need to be modified as it will not communicate with the Rear Display unit.
3. If a heat sink is not present, the CPU PCBs will need to be exchanged with upgraded PCBs. To receive exchange PCBs, contact the Brunswick Electronic Repair Center or an authorized Exchange Depot. Please note that an exchange fee will be charged for each board. You can contact the Electronic Repair Center by calling 1-800-937-2695 or 231-725-4966, or sending an e-mail to [erc@brunbowl.com](mailto:erc@brunbowl.com) to receive a CPU upgrade replacement and current pricing information.
