SERVICE BULLETIN

Subject: Incorrect Vector Global Audio Wiring Diagram

Bulletin No. SB05-4

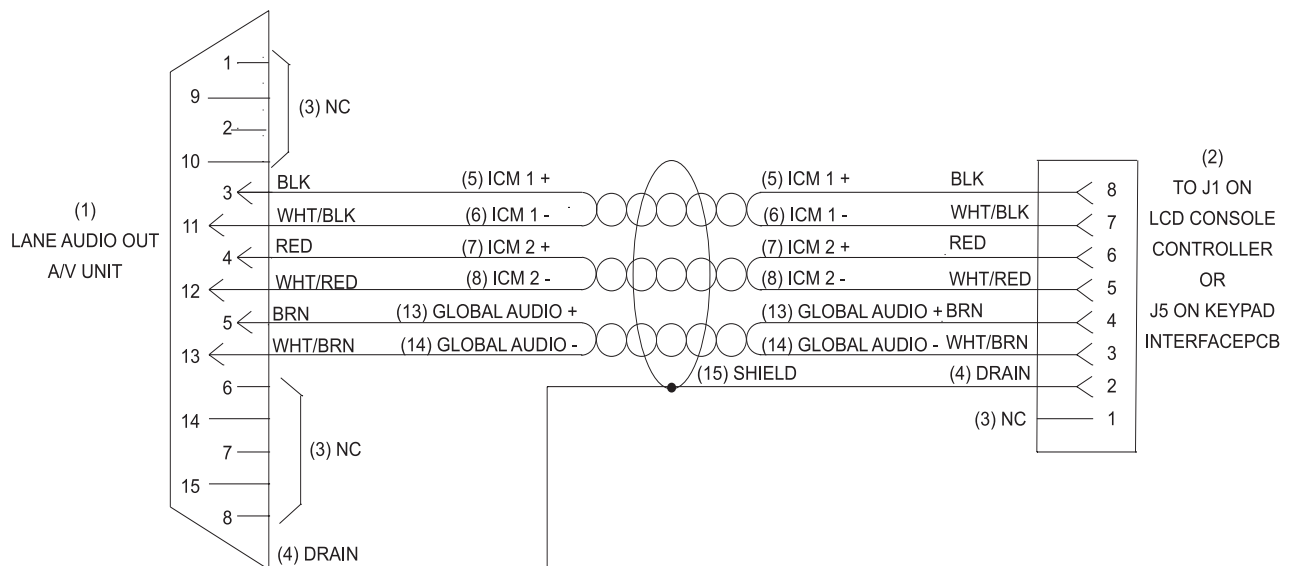
It has come to our attention that the Global Audio wiring diagram on page 56 of the Vector Scorer Service Manual, part number 57-900621-000, is incorrect. Figure 1 shows the incorrect diagram and Figure 2 shows the correct diagram.

*Incorrect Diagram
Figure 1*
