SERVICE BULLETIN

Subject: LCD Console & LCD Power Supply Rework

Distribution: Vector Scoring Customers

Bulletin No. SB07-1

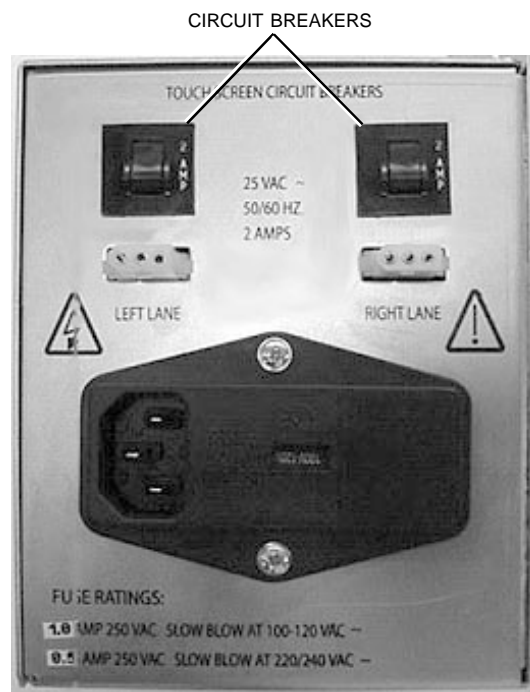
Figure 1

The location of the circuit breakers is shown in *Figure 1*. Before replacing the circuit breakers, all the cables to the power supply must be disconnected. The circuit breakers need to be replaced one at a time.

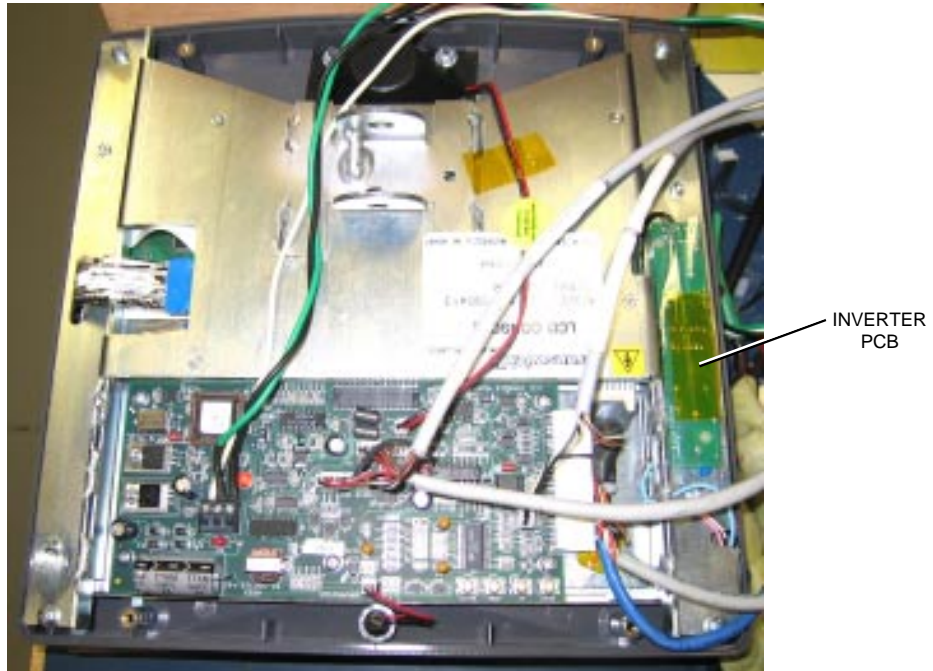
Figure 4

The current version LCD, part number 57-500413-401, has clear cellophane covering the Inverter PC Board. The clear cellophane material is not thick enough to prevent a sharp solder point from puncturing the surface. If a solder point punctures the surface of the cellophane an electrical shock could occur. *Refer to Figure 4.*
