SERVICE

Subject: Motor Drive Screw Interference Problem

Letter No. CEB00-2

Inspect and Correct A Drive Pin Interference - Automated BallWall Systems

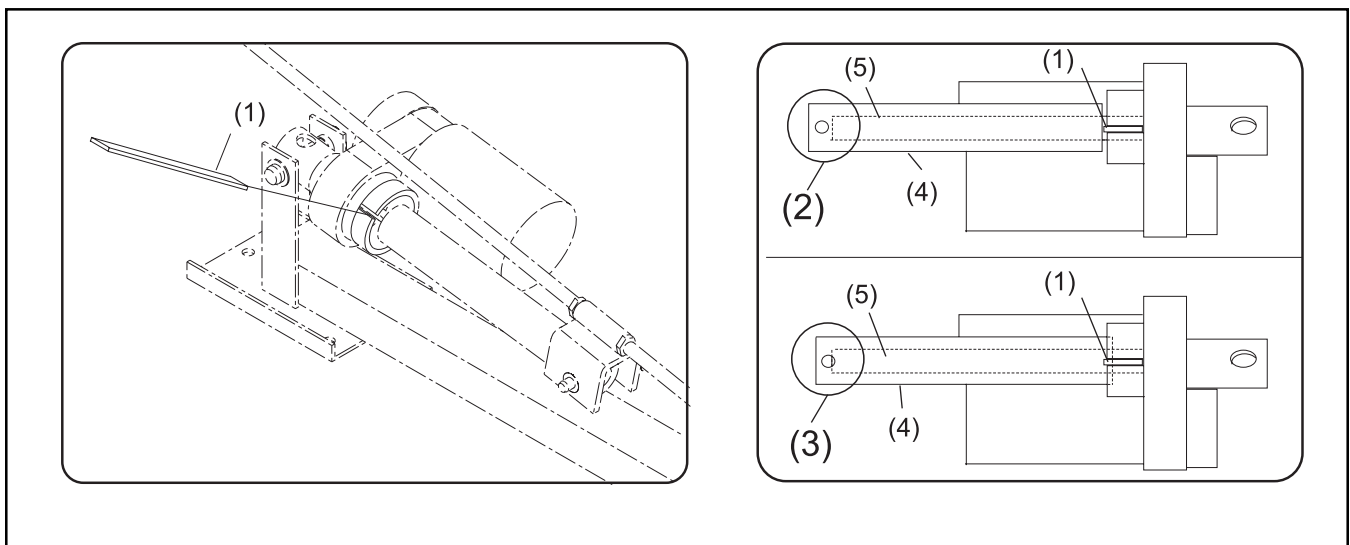
Figure 2. Use Gage to Determine if Interference Exists

- c. If switch indication is not "closed" , proceed to step 2 to make a switch adjustment. If switch is in closed state, proceed to step d.
- d. Insert a go-no-go gage (part number 17-300270-000) into the slot of sleeve casting. Refer to *Figure 2*. If gage fits into slot as shown, and end of gage contacts the drive screw, no drive pin interference exists and additional adjustments are NOT necessary. If the gage does not fit into slot or contact the drive screw, proceed to step 2 to make cam switch adjustment.

| (1) GAGE | (2) NO INTERFERENCE EXISTS - GAGE ISN'T BLOCKED BY SLEEVE | (3) INTERFERENCE EXISTS - GAGE IS BLOCKED BY SLEEVE |

2. Adjust motor cam switch to increase clearance.

- a. Make cam switch adjustment following steps in "Actuator Adjustments - Motor Limit Switch Cams" paragraph in the Automated BallWall System Operations and Service Manual until the switch indicates a "closed" state.

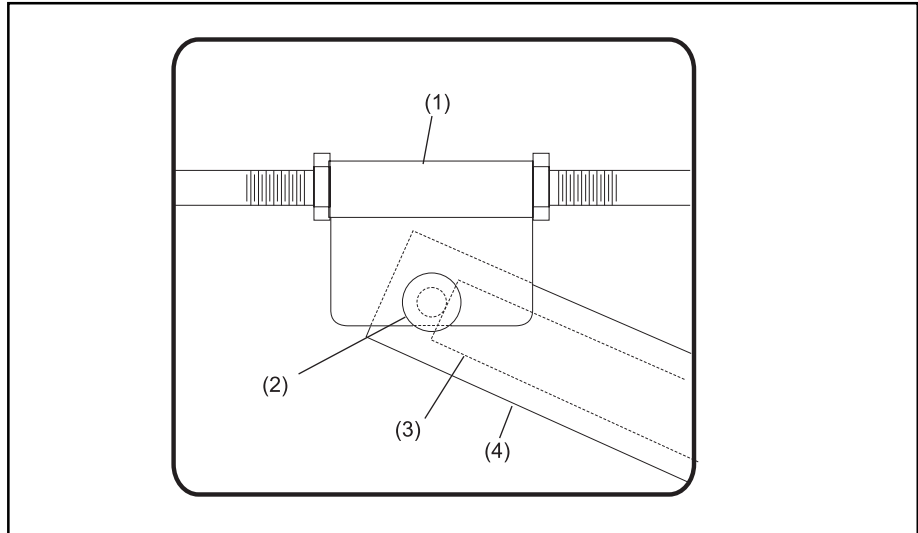
Figure 3. Check For Interference

- a. Place the bumpers in the open (up) position.
- b. Disconnect power cord from the automated bumper controller.
- c. Remove the Ball Wall curtains as necessary to gain access to gutter pivots.
- d. Disconnect clevis pins from the gutter clevis assemblies for both gutters. Refer to *Figure 1*.
- e. Mark position of the actuator motor base by tracing an outline with marker on the floor.
- f. Remove actuator motor base mount bolts and retain for reinstallation.
- g. Lift the actuator motor above the lane for easy access to linkages.
- h. Disconnect the yoke pin from the center pivot point and the motor sleeve. Refer to *Figure 3*. Visually inspect pin for evidence of wear. If wear is present, the pin was most likely interfering with motor drive screw. Retain all pins and retainers for reinstallation.

NOTE: Replace yoke pin if excessive wear is present.
