SERVICE BULLETIN

Subject: PCCharge Support

Bulletin No. SB11-2

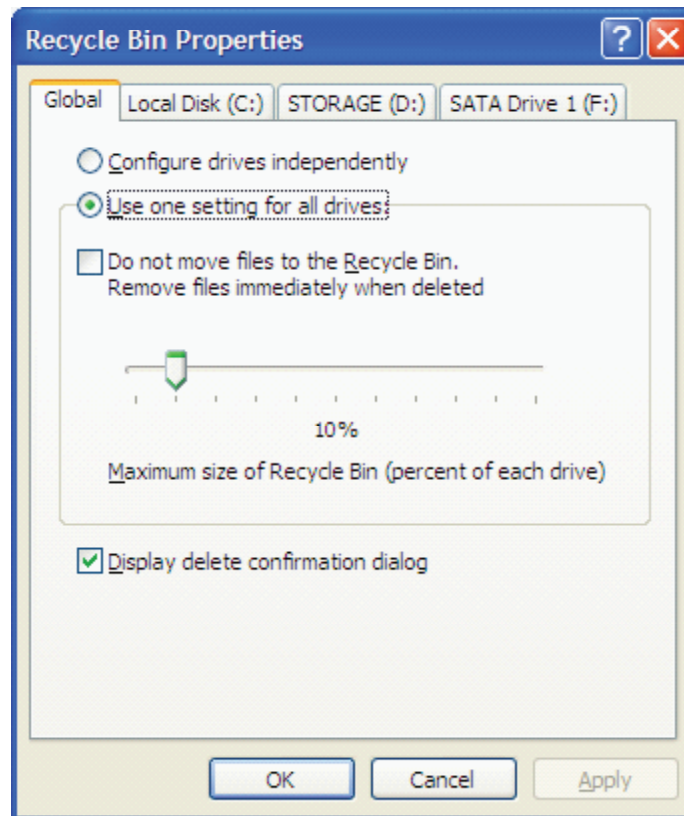
- **Duplications of credit card transactions.**
 - Duplication can be caused by the PCCharge batch process being unable to complete due to the recycle bin being full. The batch process sends the current batch file into the recycle bin for deletion. If the bin is full, the file continues to build and sends duplicate information to your processor. You may see files such as xxxx.Ifz, xxxx.ENC, normal pccw.mdb files and many others in the computer's Recycle Bin. The xxxx.xxx files naming convention will depend on the payment card processor you have selected. All vendors have their own file types that can be sent to the recycle bin. You can test for this problem by creating a document file and then try to delete the file. If the file can not be sent to the recycle bin it will tell you the bin is full.

To eliminate this issue, one of the following three options must be undertaken.

1. Choose to delete files immediately by selecting “**Do not move Files to the Recycle Bin.**”
2. Increase the disk space used for the Recycle Bin on each disk by selecting “**Configure drives independently**” or “**Use one setting for all drives.**”
3. Empty the Recycle Bin manually on a weekly basis.

Right Click on the Recycle Bin and select Properties to get this screen.
