SERVICE BULLETIN

Subject: Safety Reminder for Inspection of Omni Seating Support Frames

Bulletin No. SB08-3

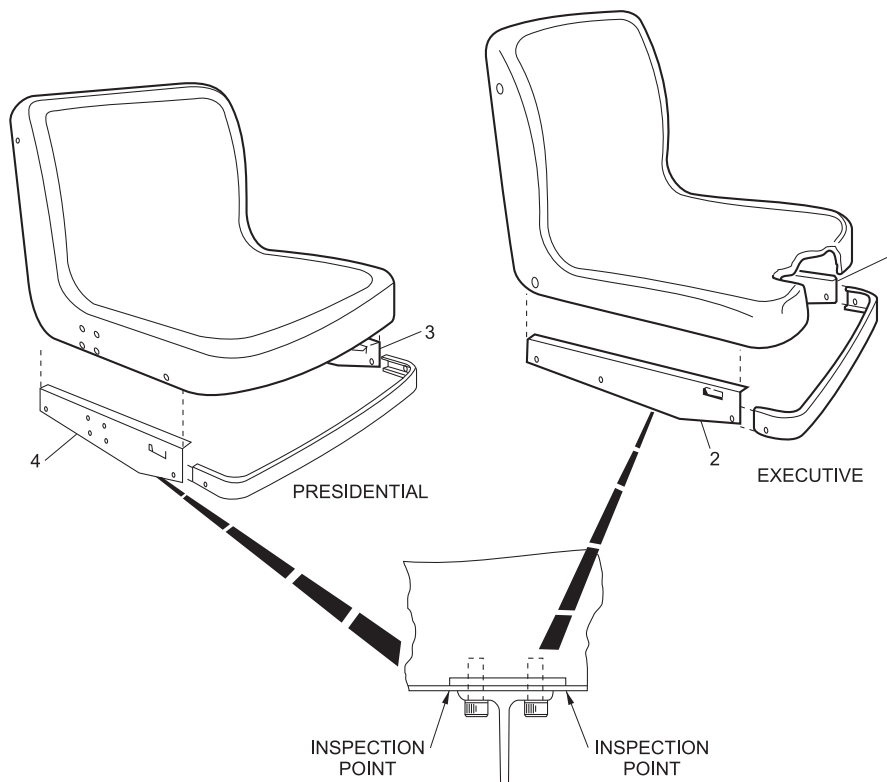
As this product reaches the end of its expected life cycle, (which is dependent on the amount of use), it is important to inspect the seat support brackets for fatigue when performing your regular inspection per Service Bulletin 86-8, a copy of which is attached to this Bulletin. Over time the metal support bracket will fatigue around the contact points of the nut plate. This is a natural stress point, so we advise immediate replacement with the appropriate bracket listed below upon any signs of fatigue or after a few years of heavy use.

| 1. | Executive L.H. Support Bracket | (P/N 54-100439-003) |
| 2. | Executive R.H. Support Bracket | (P/N 54-100439-002) |
| 3. | Presidential L.H. Support Bracket | (P/N 54-100438-003) |
| 4. | Presidential R.H. Support Bracket | (P/N 54-100438-002) |

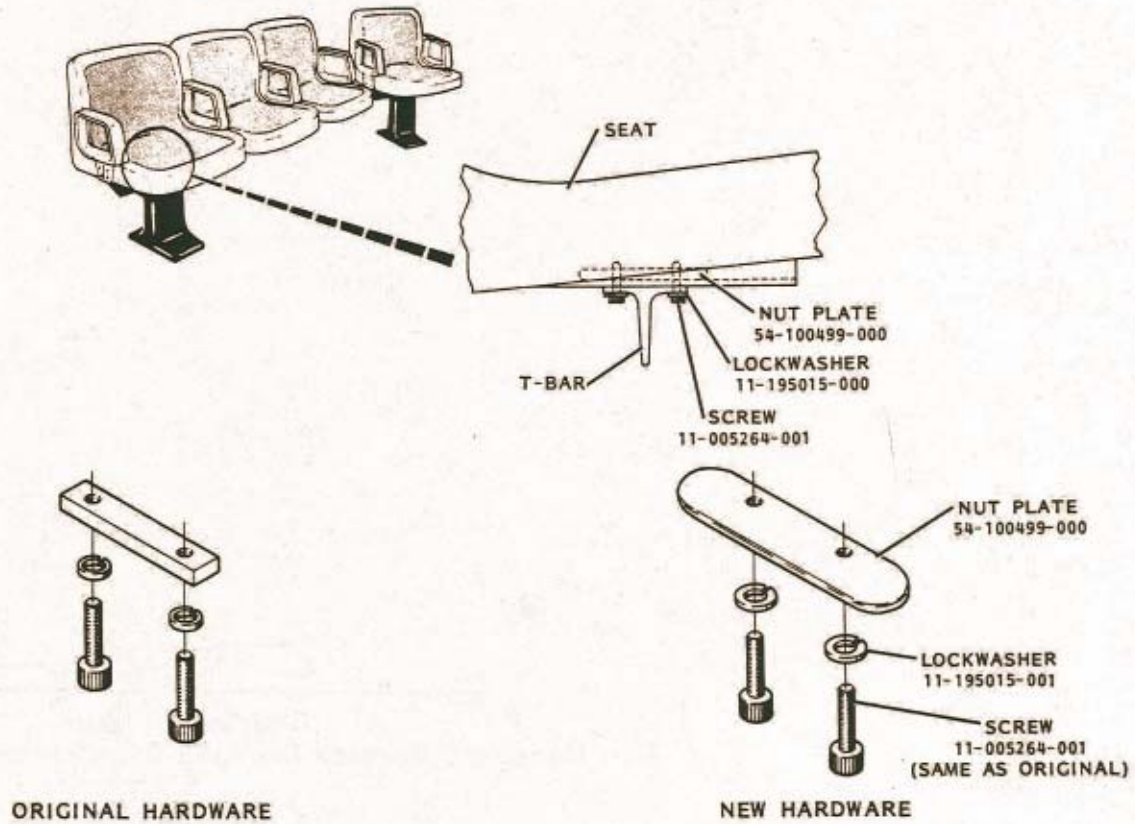
FIGURE 1

Brunswick has investigated field reports of failed Omni seat support brackets. This failure is generally seen in centers where the seating hardware has not been included in periodic general maintenance.

Newly designed parts have proven to reduce the frequency of tightening the screws. See Figure 1.

Omni seating, as does most equipment in a bowling center, requires maintenance. The amount required is small, but the importance is great. It is our recommendation for a center to periodically inspect all seating. The frequency of these inspections is dependent on usage. If a seat is found to be loose, the mounting screws should be tightened to a torque of 18 foot pounds. Should this procedure not be followed, irreversible damage to the hardware will result.

These parts are available under the following part numbers:

<u>Part Number</u>	<u>Description</u>
54-100499-000	Nut Plate/Support
11-195015-001	Lockwasher/Nut Plate
11-005264-001	5/16" Bolt (Same As Original)
