SERVICE BULLETIN

Subject: Phoenix Lite Not Conditioning

Bulletin No. SB14-10

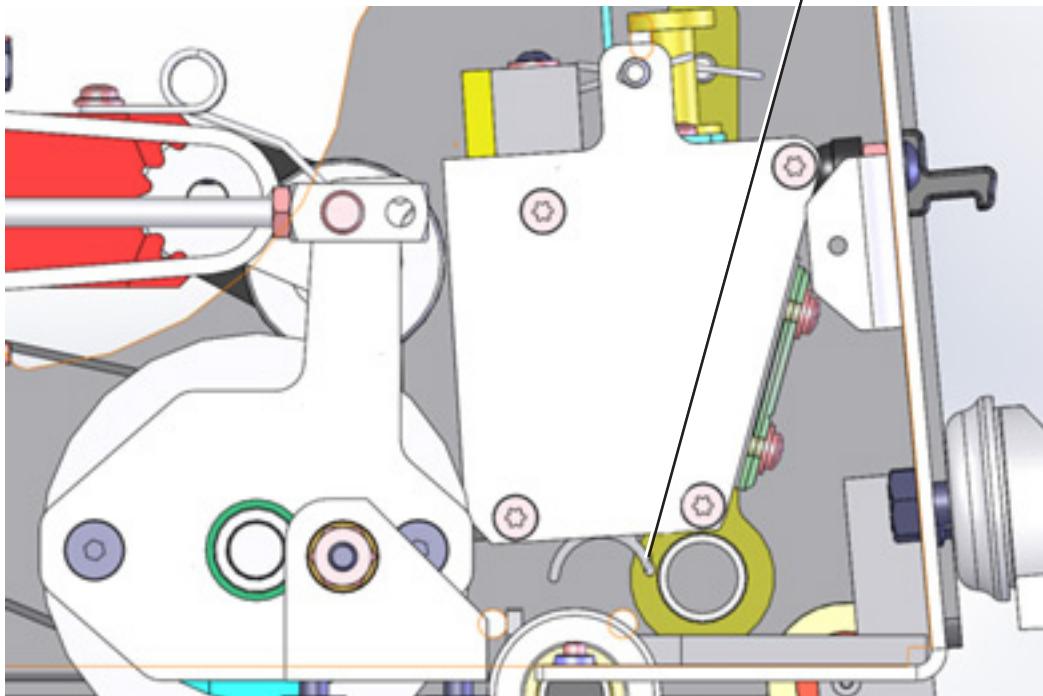
Figure 1. Tank Positioned Incorrectly on Support Tube

We have received reports that the Phoenix Lite LT4 lane machine can suddenly stop conditioning. Upon further investigation, we have determined that this may occur if the tank was removed (for cleaning or changing wicks) and reinstalled incorrectly in the machine.

The tank must be mounted correctly on the support tube so that it rests properly against the transfer roller. An improperly mounted tank will ultimately result in the conditioner not being applied to the lane surface. We have found that it is possible to align the tank with its retaining bracket, yet still install the tank incorrectly. Refer to Figures 1 and 2.

TANK RESTING IN FRONT OF
SUPPORT TUBE.
REMOVE AND CORRECTLY
POSITION ONTO SUPPORT TUBE

It is easiest to check for proper mounting with the machine in the upright or storage position. In this position you can see the bottom of the oil tank and the support tube that it is resting on.
