SERVICE BULLETIN

Subject: Phoenix Lite LT4

Date: 6/2/14

Bulletin No. SB14-9

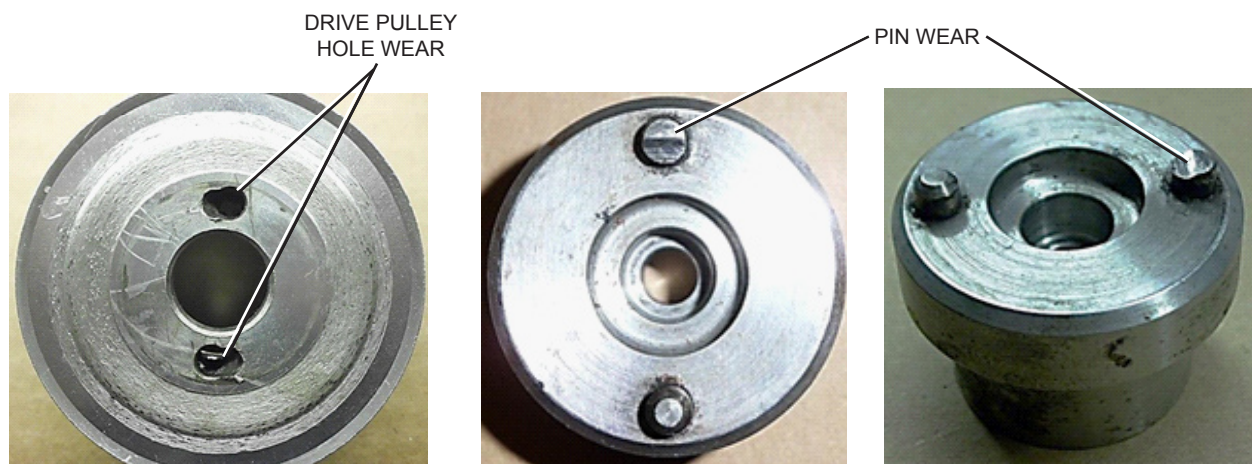
Figure 1. Buffer Brush Pin and Hole Wear

We have seen premature wear on the pins and correlating holes in the drive pulley on some Buffer Brush assemblies (P/N 294-116-065) used in the Phoenix Lite LT4 Lane Machines manufactured before 5/5/2014. When wearing occurs between the pins and the drive pulley holes, the buffer brush will begin to make a scraping noise during operation. If the wear becomes excessive, the buffer brush may disengage and fall out of the lane machine. Refer to Figure 1.

The cause of the wear has been determined to be a result of poor engagement of the pins on the buffer brush hub into the drive pulley. This poor engagement is due to the pins being pressed too far into the buffer brush hub during the manufacturing process.

We recommend that you inspect the pins in the buffer brush assembly and the drive pulley for wear as shown in Figure 1. If no wear has occurred, measure the height of the pins from the surface of the hub. The pins must protrude at least a 1/4" [6.35mm] but no more than 17/64" [6.74mm] from the surface of the hub. Refer to Figure 2.

If upon inspection, there is wear showing on the pins of the buffer brush hub, in the holes of the drive pulley, or the pins measure less than 1/4" from the surface of the hub, contact Brunswick Technical Support at 800-937-2695 or email techsupport@brunbowl.com to arrange for replacement.
