SERVICE BULLETIN

Subject: DBA Phoenix-S Model C Float & Program Update Notification Date: 9/16/02

Distribution: All DBA Phoenix-S Model C Customers BulletinNo. CEB02-10

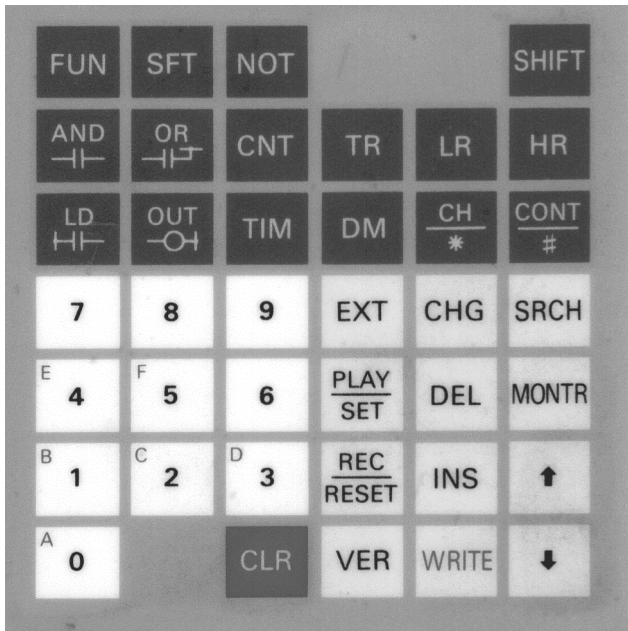
CUT OUT THE FOLLOWING GRAPHIC AND PLACE ON KEYPAD
