SERVICE BULLETIN

Subject: Ball Detect Repairs>Returns and Adjustment

Bulletin No. SB13-1

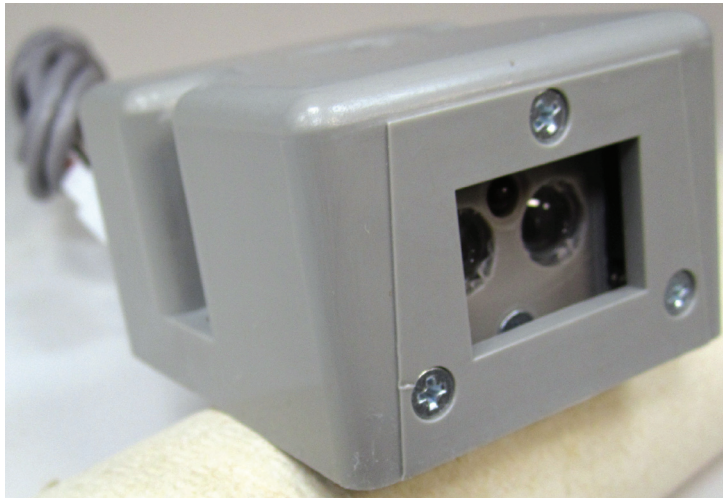
Figure 1 - 99-086292-800

Brunswick now offers the ball detect only as a repaired assembly – a single head mounted and adjusted in an enclosure. Part number for this version is 99-086292-800. Refer to Figure 1.

This is the most logical configuration of the ball detect, as it comes to you tested and pre-adjusted. You should be able to remove your failed unit and install the replacement on the mounting bracket with minimal (if any) adjustment required. (Refer to the adjustment at the end of this bulletin).

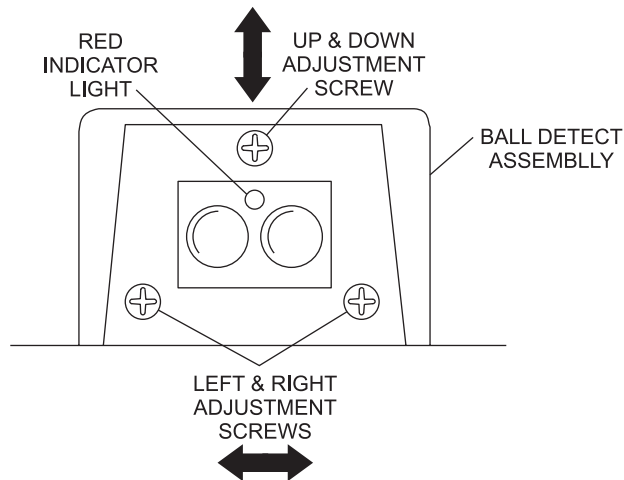
Figure 2

The ball detect assembly uses an infrared light which cannot be seen without an optical aid. Therefore, it has a red indicator light on the face of the unit that will light when insufficient infrared light is reflected back to it. Refer to Figure 2.

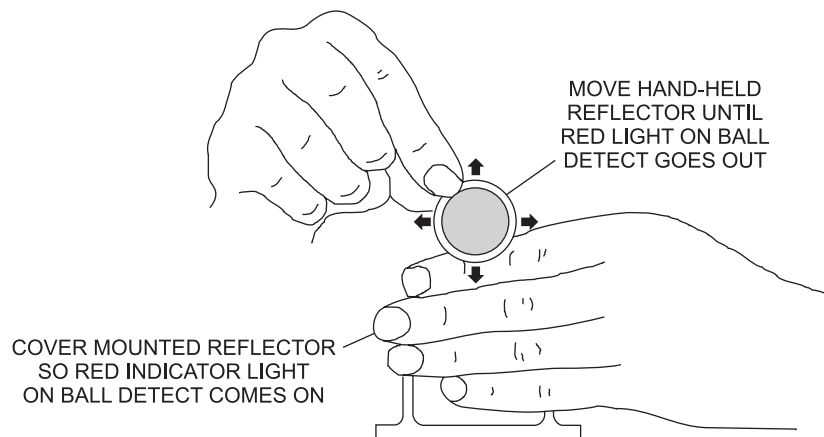
Figure 3

It is also important to note that well over 50% of the returned ball detects have “no problem found” when we receive them and the majority are simply out of adjustment. Following is a ball detect adjustment procedure that will help you to ensure your ball detect is properly adjusted.

To center the infrared beam on the reflector, use the following steps. Refer to Figure 3.

1. With power on to the pinsensor, cover the reflector mounted on the division capping so the red indicator light on the ball detect unit comes on.
2. Using another hand-held reflector, start above the covered reflector and slowly move the hand-held reflector down toward the covered reflector while holding it square to the ball detect unit. Continue to move the hand-held reflector until the red light goes out and note the position of the hand-held reflector.

3. Repeat the same procedure starting below the covered reflector (in the ball gutter) and move the hand-held reflector up until the light goes off and note that position.

4. Repeat the same procedure starting from the left of the covered reflector and then from the right until you have located the relative position of the infrared beam.
5. If the beam is not centered on the covered reflector, it can be adjusted with the three adjustment screws in the face of the unit. The top screw moves the beam up and down. A clockwise turn moves the beam down while a counterclockwise turn will move it up. Refer to Figure 2.
6. The side screws will move the beam left to right. Refer to Figure 2.
7. After each adjustment, recheck the beam's location with the hand-held reflector following the procedure detailed above.
