SERVICE BULLETIN

Subject: A-2 Magnetic Clutch Power Plug Issue

Bulletin No. SB17-3

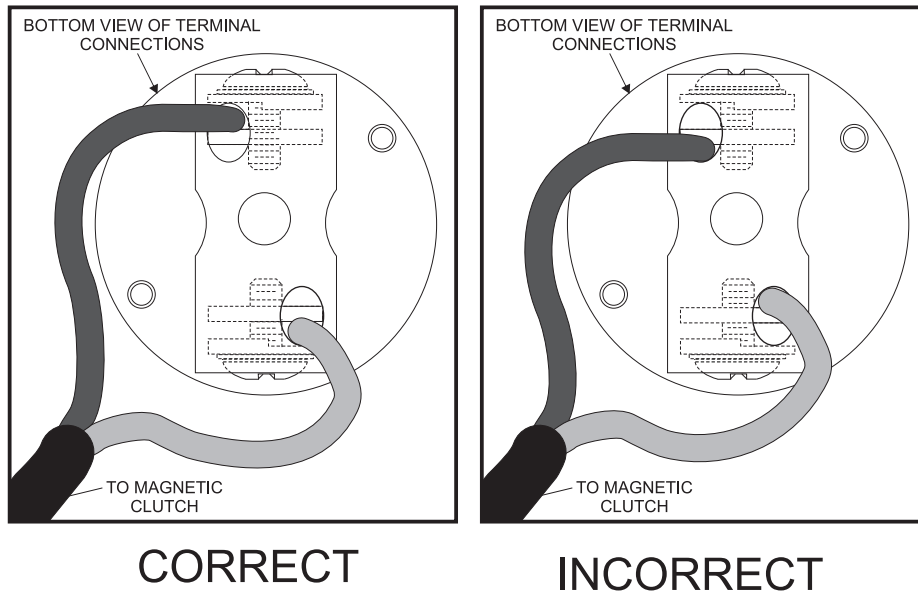
Figure 1

It has come to Brunswick's attention that part number 12-862163-000 Magnetic Clutch Power Plug, may be incorrectly assembled.

Make sure that the clutch cables are secured between the metal plates in the plug and not toward the clear plastic part. Incorrect wiring may cause the magnetic clutch not to function as intended.

Please verify the terminals connections of the magnetic clutch.
