SERVICE BULLETIN

Subject: GS Pinsetter Crank Arm Alignment

Bulletin No. SB12-8

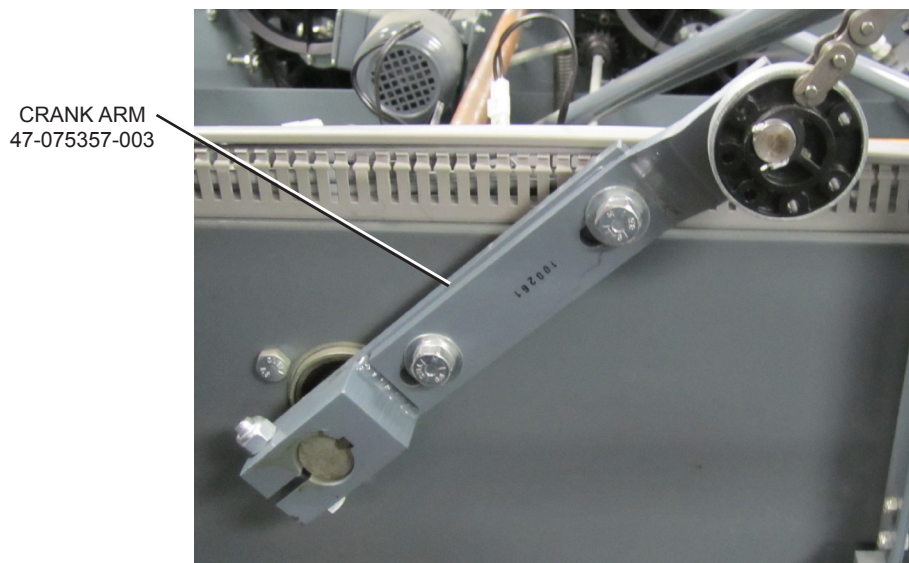
Figure 1

In April of 2008 there was a change in the thickness of the crank arm from 10mm to 12 mm. This occurred on machines with series numbers 644 and higher. Refer to Figure 1.

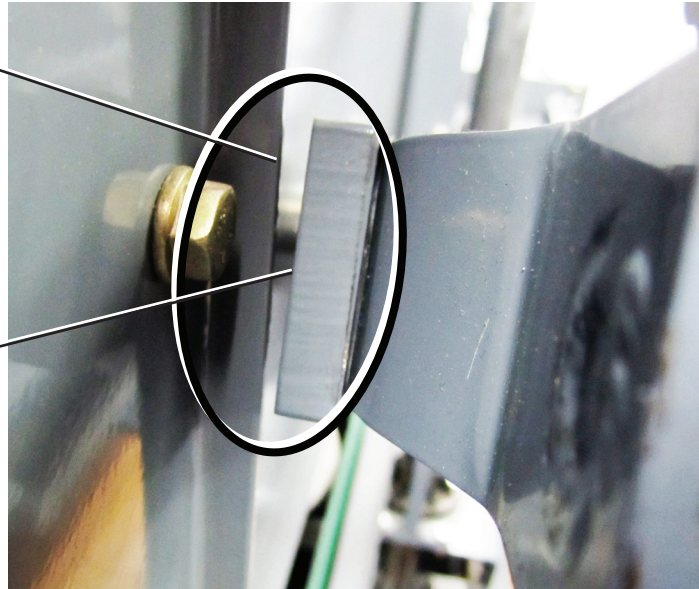
Figure 2

One of the things we have noticed is that if you have a machine that has the crank arm adjusted too far away from the distributor frame – in particular, the edge of the Sweep Shaft Support Brace (Refer to Figure 2), it can create a misalignment of the pivot bearing and the top spur gear when the crank arm is at the top of the stroke and closest to the spur gear – the pivot bearing is offset to the right of the spur gear (Refer to Figure 3).

CRANK ARM ADJUSTED TOO FAR AWAY FROM EDGE OF THE SWEEP SHAFT SUPPORT BRACE
