SERVICE BULLETIN

Subject: GS-X Pin Station Retaining Pins

Date: 5/30/14

Bulletin No. SB14-7

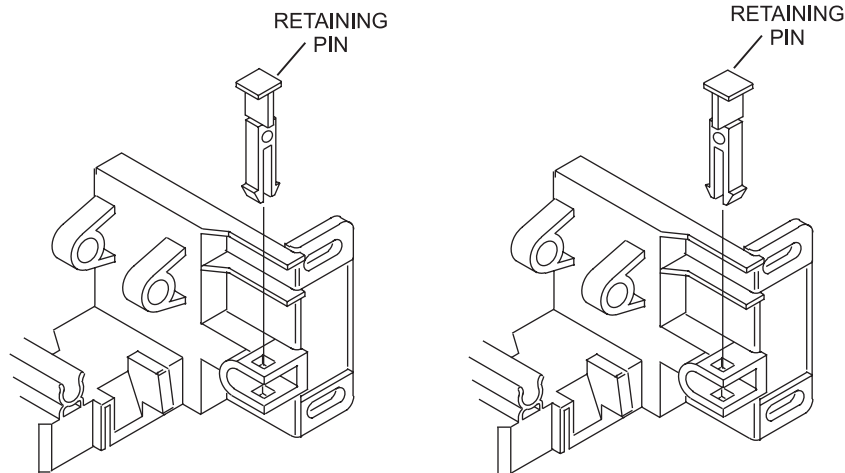
Brunswick has received reports that the retaining pins used for the retaining bows in the universal pin stations are not staying in place. This may cause the retaining bows to come loose and ultimately result in pin loading issues.

Centers that are experiencing this issue should verify that the retaining pins have been installed with the proper orientation within the pin station. Failure to install the retaining pins correctly can cause the retaining pin tabs to compress and possibly allow the pin or the bow to come loose from the pin station. The retaining pins should always be installed as shown below.

CORRECT

INCORRECT

1. The pins are now being made slightly longer to improve latching with the pin station housing. This will help keep the retaining pin in place in the event it is installed incorrectly.
2. The manufacturing procedure for pin station assemblies has been updated to ensure that the pins are being installed correctly within the pin stations.
