Subject: GS Pin Slider Modification Date: 3/5/01

Distribution: All GS Pinsetter CustomersLetter No. CEB01-3

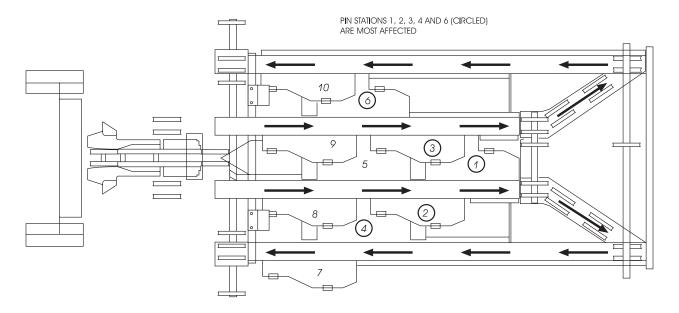
Figure 1

A number of customers with GS Pinsetters containing the gray and black pinholder assembly have reported problems with pins shooting forward when they are loading into pinholder. This causes the pin to not be correctly located in the pinholder and therefore to not activate the switch in the pinholder. In some cases the pin will shoot completely forward and fall out of the front of the pinholder.

The pin positions most affected with this condition are positions 1, 2, 3, 4 and 6. Refer to Figure 1.

The following field modification can be made to the pin slider assembly to prevent this.
