Subject: GS Pinsetter Corner Belting Angle Reduction Date: 5/22/01

Distribution: All GS Pinsetter Customers Letter No. CEB01-4

Distributor Corner Belt Angle Reduction

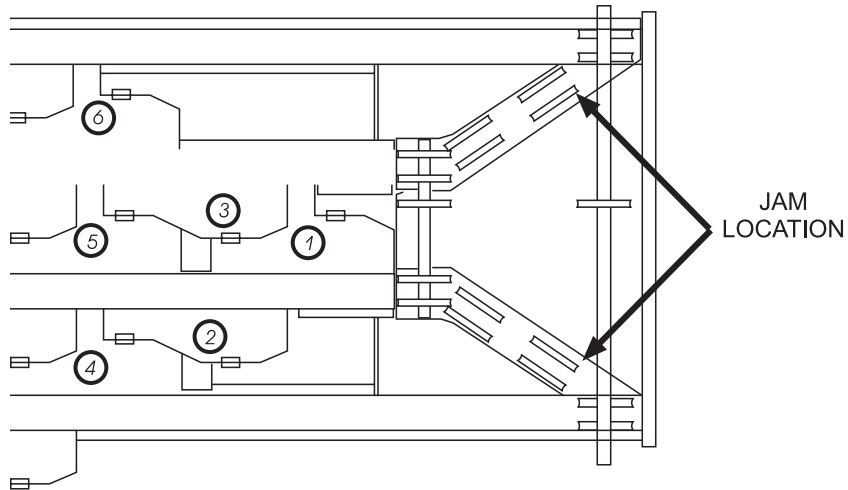
Figure 1

With the changing world of lane conditioners and cleaners, we have noticed an increase in pin jams in the front corners of the GS Series Pinsetter distributor. Refer to *Figure 1*. We have devised and tested a procedure that reduces the occurrence of the corner jams. The pages following detail this simple procedure that takes approximately 20 minutes per pinsetter.

In addition, we recommend that you be ever diligent in cleaning your green belts with lane cleaner. We have found that Invincible Lane Cleaner (P/N 62-860055) works well in removing the new conditioners that may contain silicone which has been causing many of the problems you are facing. Also as a part of regular maintenance, you must keep the belts adjusted and tensioned properly. Finally, don't forget to clean the bowling pins, pindecks and transport bands that track the oil to the belts in the first place.

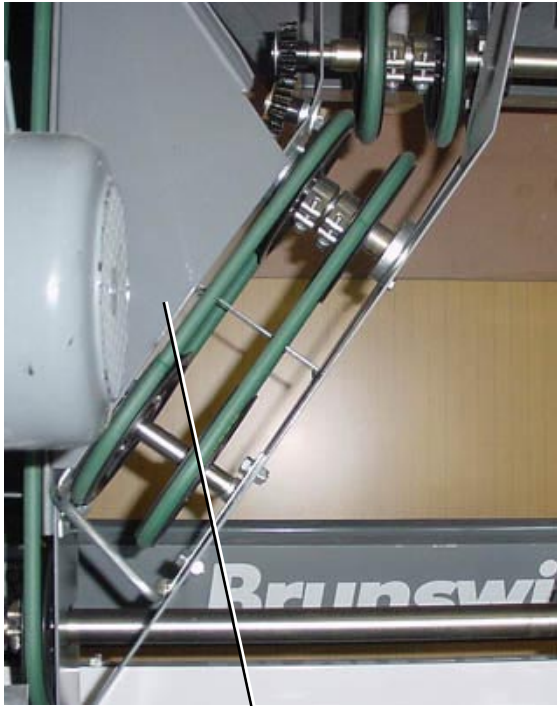
Figure 2

CORNER TURN PLATE

1. Remove corner turn plate. Refer to *Figures 2 and 3.*

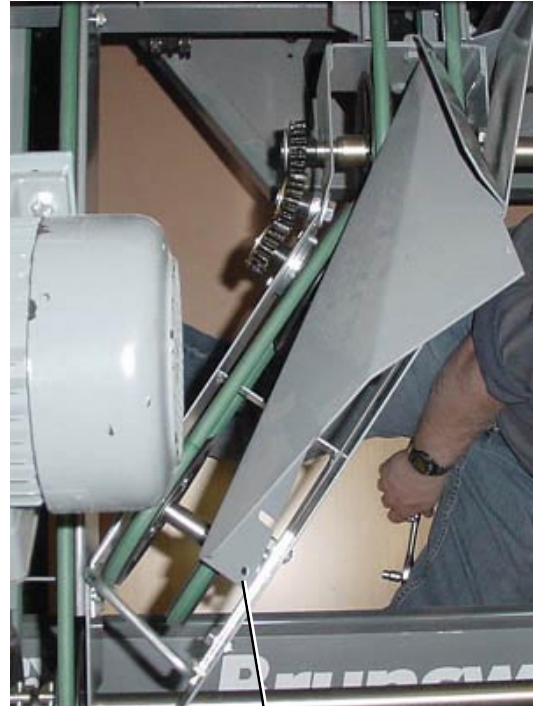
Figure 3

CORNER TURN PLATE
REMOVED

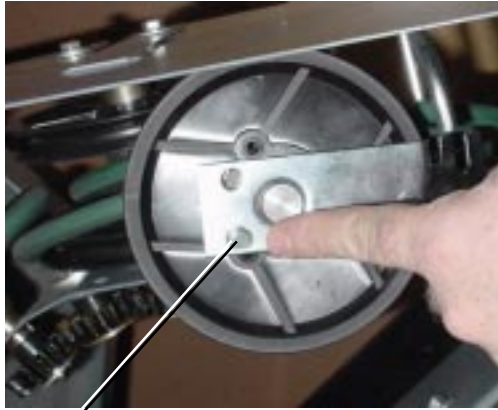
Figure 5

OLD BOLT
BOTTOM LOCATION

3. Remove the front dual-pulley assembly. Change the bolt to the upper hole *Figures 5 and 6*.

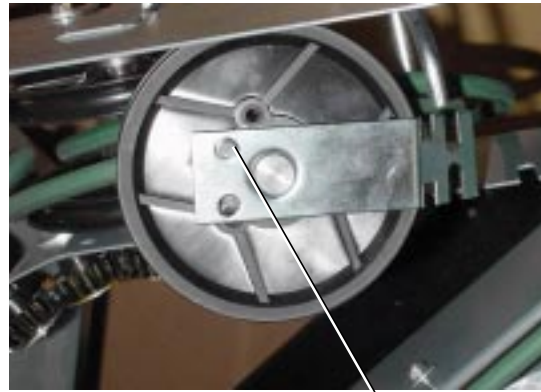
Figure 6

NEW BOLT
TOP LOCATION
