SERVICE BULLETIN

Subject: IMPORTANT Safety Notice - Ceronix 1492 Chassis

Bulletin No. SB05-3

Letter No. SB04-3

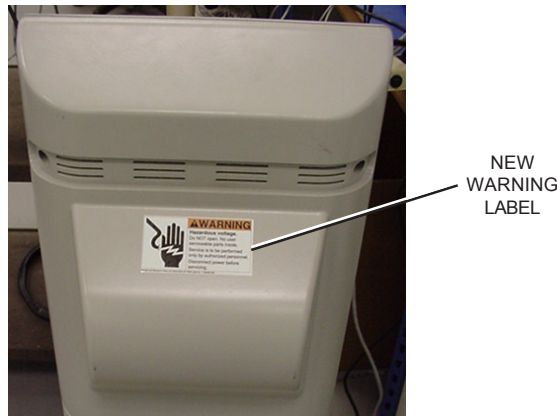
Figure 1. Warning Label placed on back of Powerworx scoring console.

To help better protect you and your employees, we are including a warning label sticker to affix to the back cover of your scoring console. Refer to Figure 1.

Last year, we issued Service Bulletin SB04-3 that discussed the electrical shock hazards presented by the Ceronix Model #1492 when working with the scoring console in a “powered on” state. This specifically included, but was not limited to adjusting of the G2 (screen) and/or focus for the monitor. We wanted to follow up with you to ensure that you were following the procedures outlined in the Service Bulletin.
