# SERVICE BULLETIN

**Subject: GS-X Nexgen Rear Display Upgrade Package****Date: 8/18/10****Bulletin No. SB10-10**

## **Nexgen Rear Display 47-861048-000**

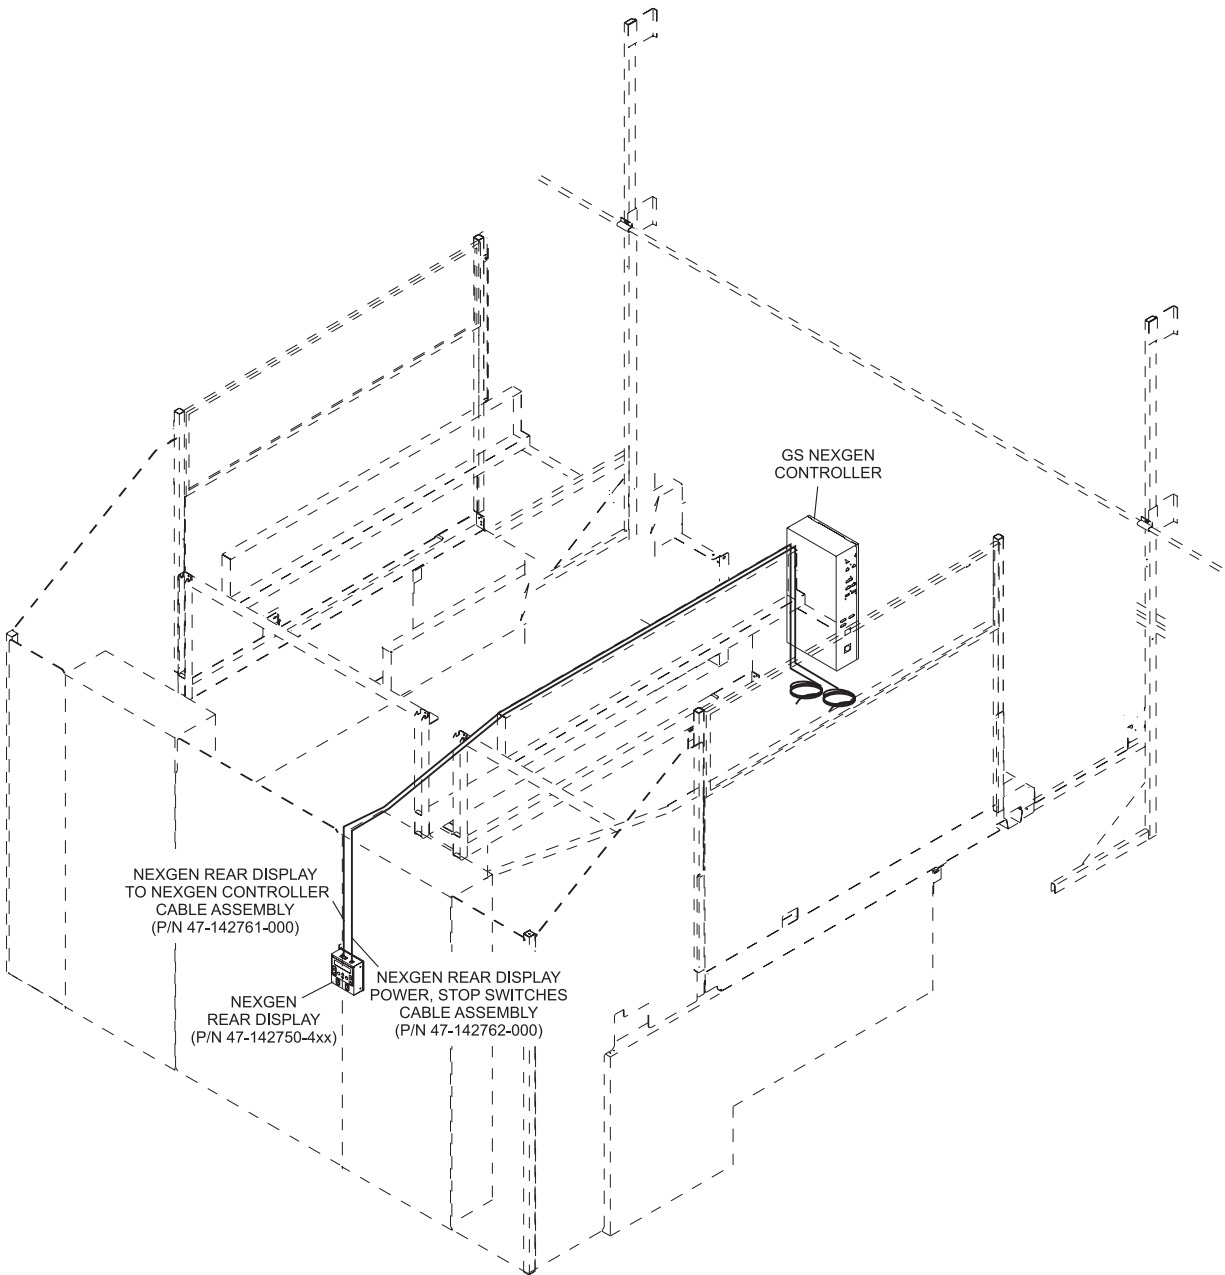
*Figure 1*

1. Replace the existing EPROM chip. Utilize the instructions packaged with the EPROM chip (P/N 47-862509-400).
2. Route "GS-X Rear Display Box to Nexgen" cable assembly (P/N 47-142761-000) and "GS-X Rear Display Box Power, Stop Switches" cable assembly (P/N 47-142762-000). Refer to *Figure 1*.

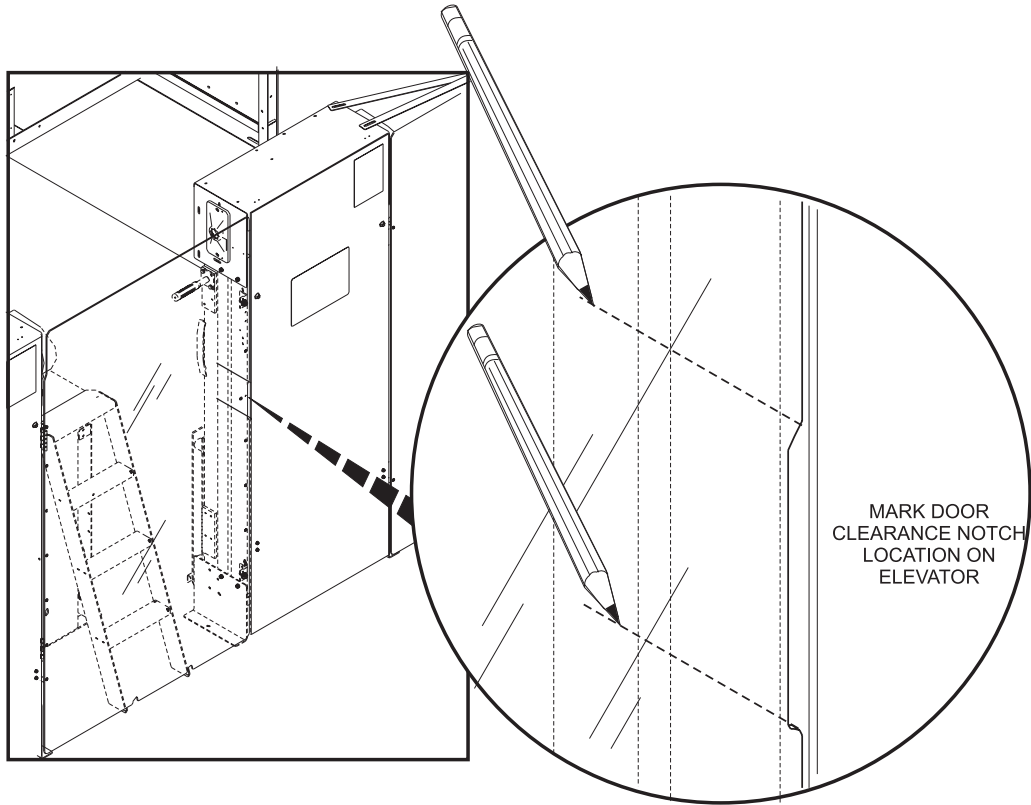
*Figure 2*

1. Close rear door and mark location of door's clearance notch on the side of the elevator. Refer to *Figure 2*.

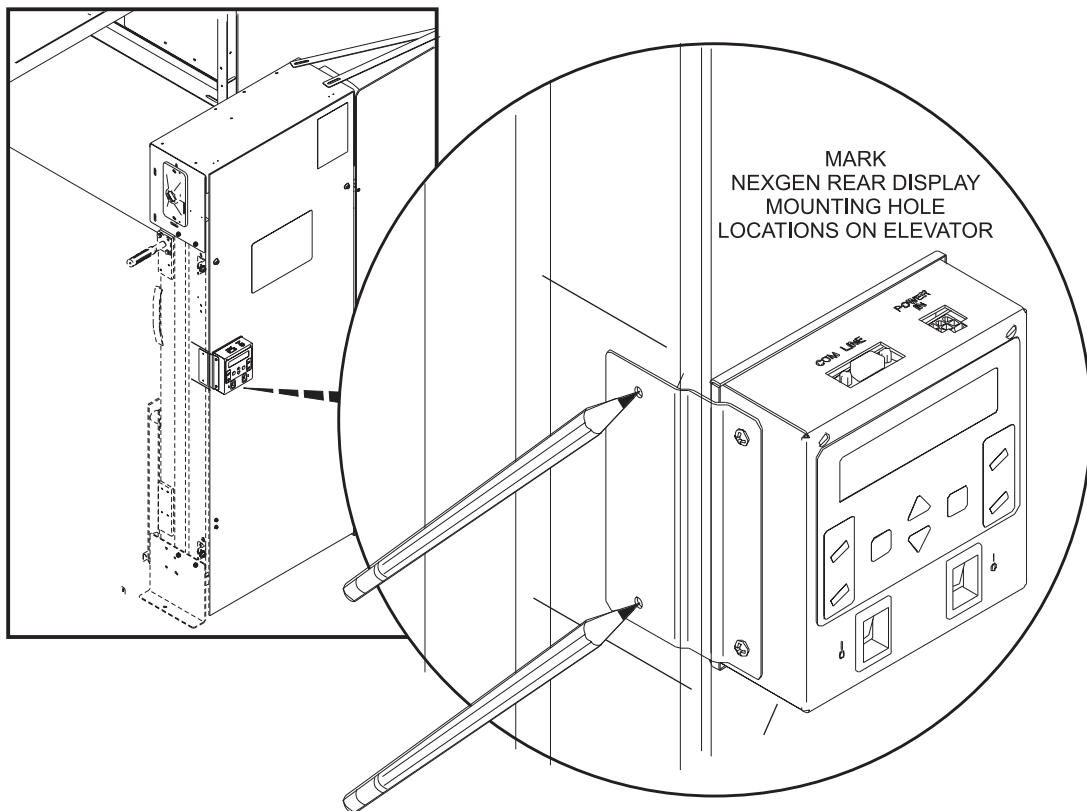
*Figure 3*

2. Center Remote display between lines marked on side of elevator in *step 1* and mark location of mounting holes. Refer to *Figure 3*.

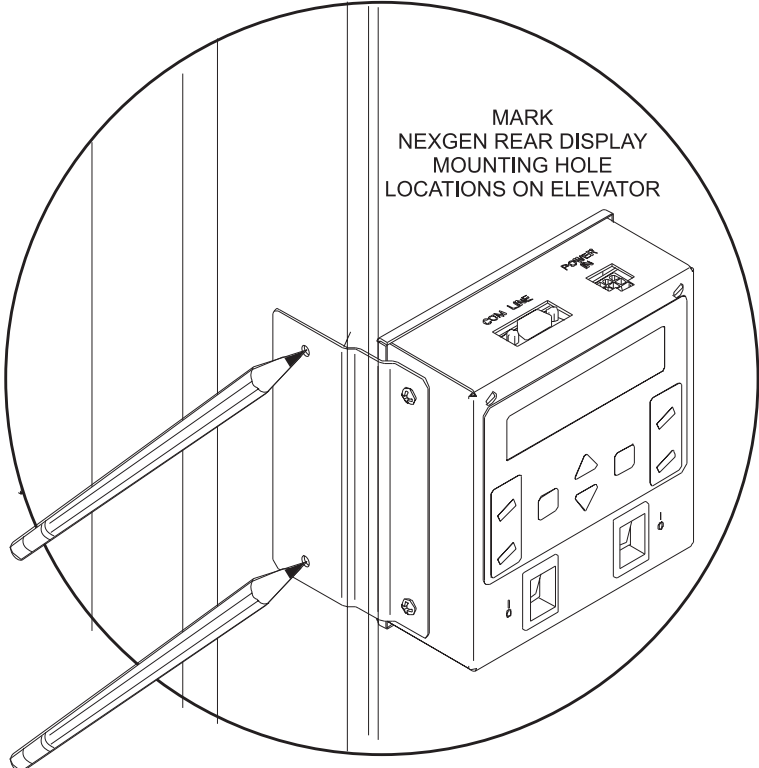
Figure 4

- 1. Place the Nexgen Rear Display (P/N 47-142750-4XX) in a location on the elevator that allows proper function of any existing doors or guards and within reach of both cable assemblies.
- 2. Mark location of mounting holes. Refer to *Figure 4*.

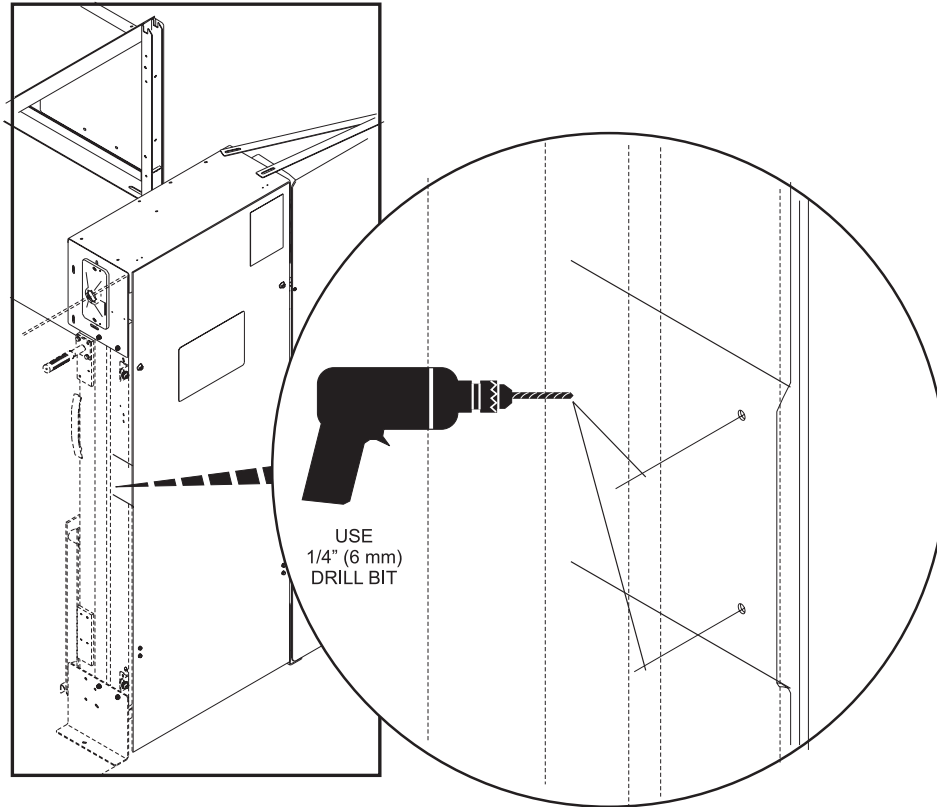
*Figure 5*

1. Drill 1/4" Diameter thru holes at marked mounting hole locations on elevator. *Figure 5.*

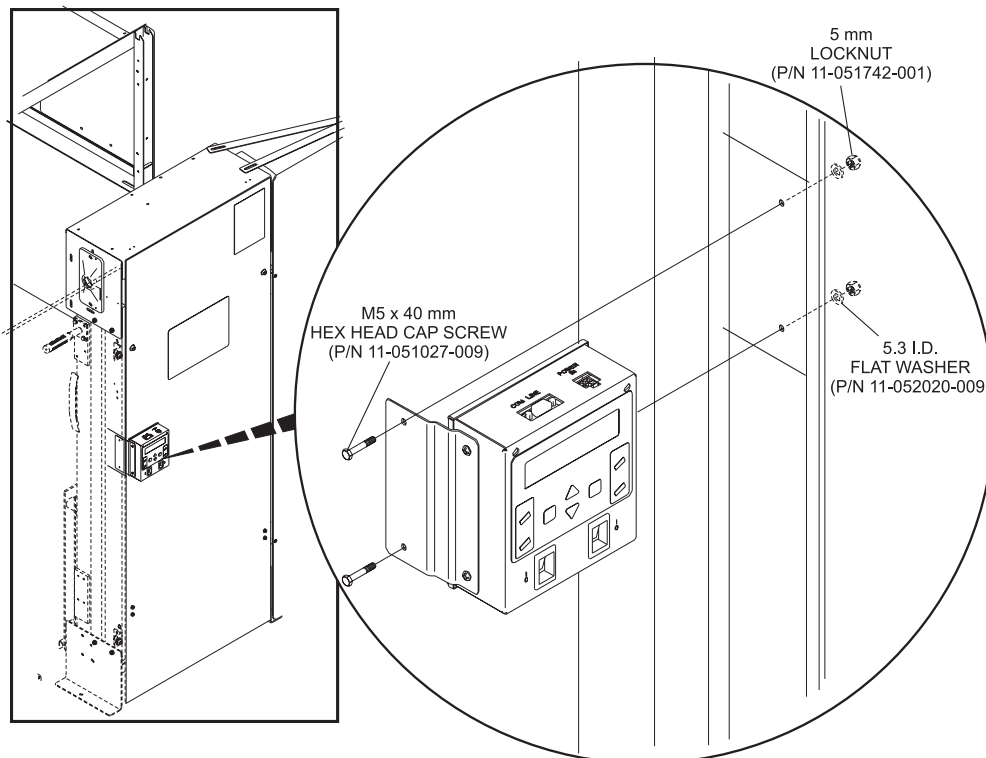
*Figure 6*

2. Secure Remote Display to the elevator with two M5 x 40 mm hex head cap screws (P/N 11-051027-009), two 5.3 mm I.D. flat washers (P/N 11-052020-009) and two 5 mm locknuts (P/N 11-051742-001). Refer to *Figure 6.*

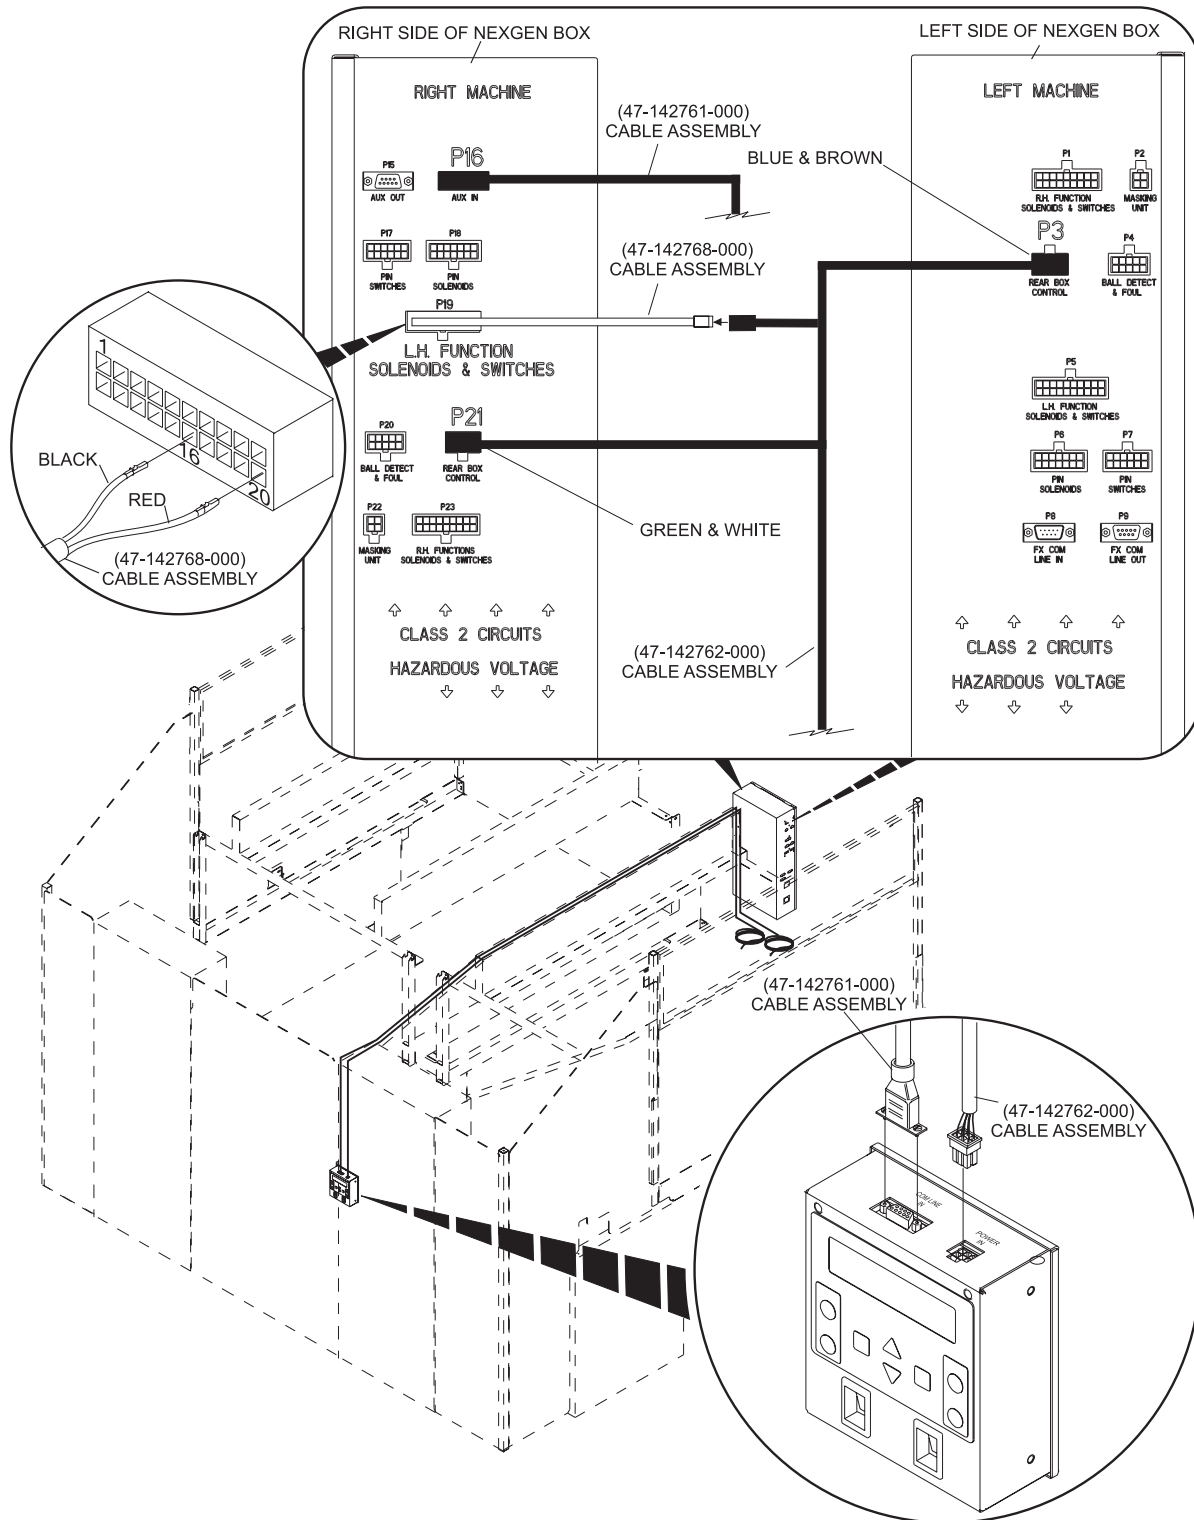
Figure 7

3. Connect cable assembly (P/N 47-142761-000) to "P16" on the Nexgen box and "COMLINE IN" on the remote display. Refer to Figure 7.

4. Connect pins from cable assembly (P/N 47-142768-000) to existing "P19" connector. Refer to Figure 7.
5. Connect multi connector end of cable assembly (P/N 47-142762-000) to "P3", "P21" and cable assembly (P/N 47-142768-000) on the Nexgen box. Refer to Figure 7.
6. Connect single connector end of cable assembly (P/N 47-142762-000) to "POWER IN" on the remote Display box. Refer to Figure 7.
