SERVICE

Subject: Motor Drive Screw Interference Problem

Letter No. CEB00-2

Inspect and Correct A Drive Pin Interference - Automated BallWall Systems

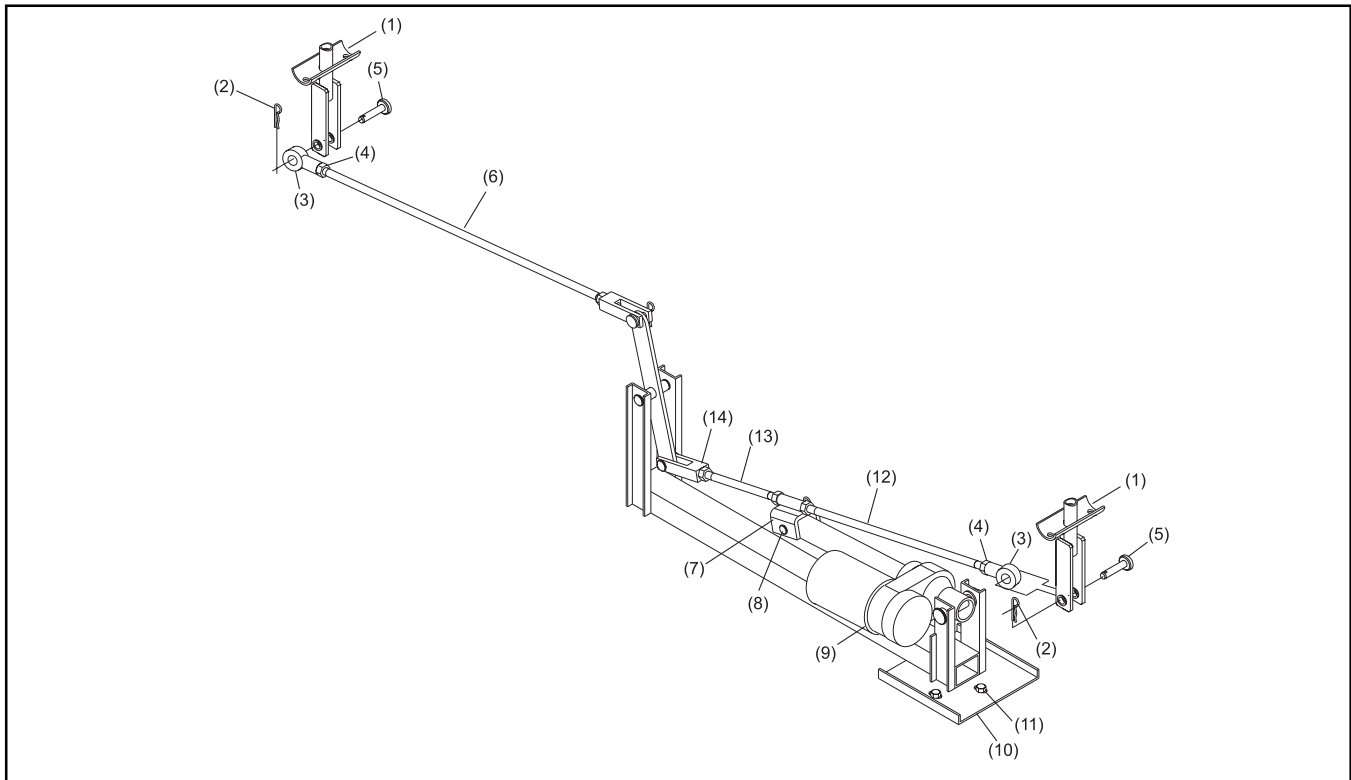
Figure 1. Component Identification

The following procedures list the steps required to inspect for and then correct an unacceptable interference between the actuator motor drive screw and the yoke pin on the mechanical linkage. These steps should be accomplished after the components have been initially installed (i.e., mechanical linkages are connected, bumpers close beneath lane surface, etc.). Refer to *Figure 1*.

1. Check for interference between the actuator motor drive screw and yoke pin of mechanical linkage rods.
