SERVICE BULLETIN

Subject: Ball Detect Repairs>Returns and Adjustment

Bulletin No. SB13-1

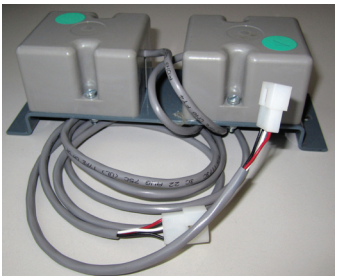
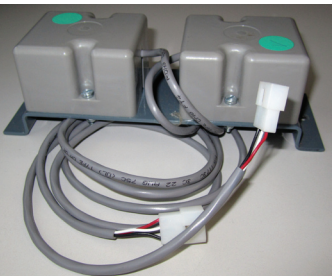
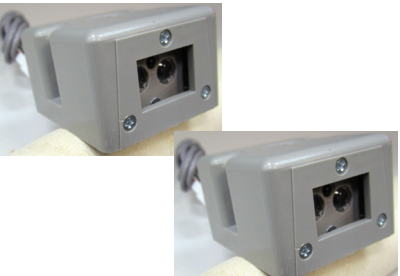
On occasion, we have returns that do not match this configuration. The following table contains information on how the return and billing will be handled, going forward.

IF YOU RETURN THIS:	YOU WILL RECEIVE THIS:	YOU WILL BE CHARGED FOR THIS:

If you need ball detects pre-shipped to your center, that can be done for an additional service fee. It is important that you return the same configuration ball detect as what you ordered. We recommend that you keep this Service Bulletin handy for future reference when ordering a pre-ship from your repair/exchange depot.
