SERVICE BULLETIN

**Subject: Ceronix Overhead Monitors -
AC Power Receptacle - 57-301032-000**

Bulletin No. SB04-6

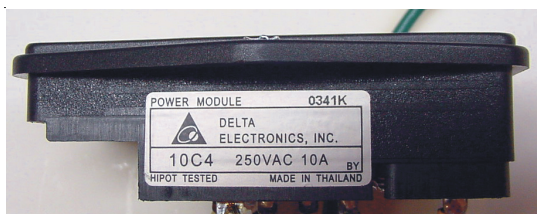
FIGURE 1

It has come to our attention that the AC power module from Delta Electronics, (refer to Figure 1), is being manufactured with the fuse connector clips spread open too wide for the fuse. Refer to Figure 2.

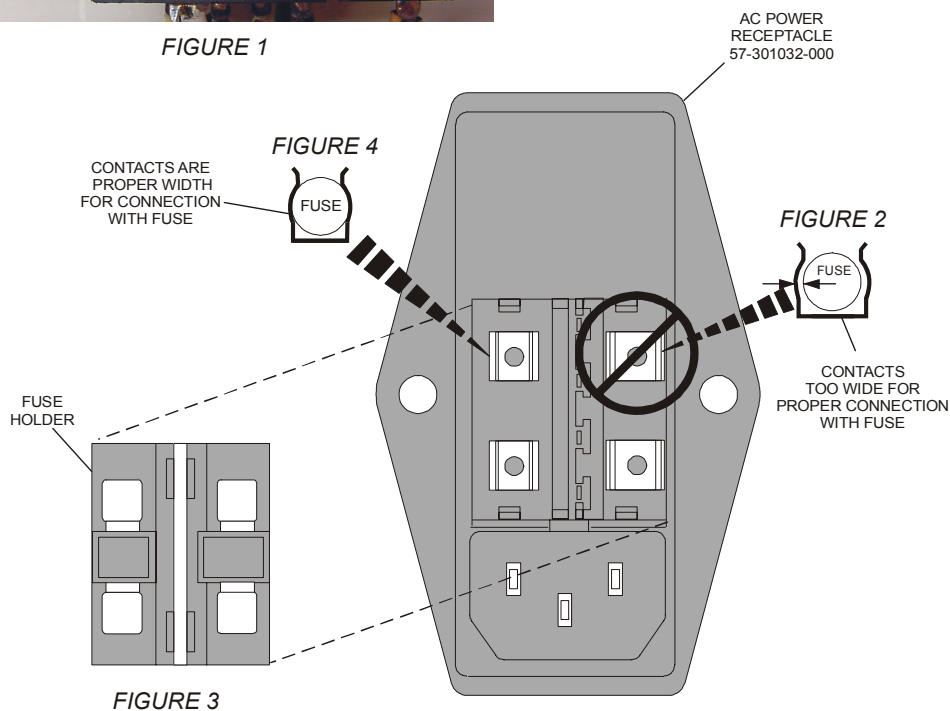
FIGURE 3

The failure from this defect is intermittent power loss to the overhead monitors.

1. Remove the power plug from the power module.
2. Remove the fuse holder block. Refer to Figure 3.
3. Squeeze the fuse connector clips together so that they make a solid connection with the fuse. Refer to Figure 4.
